# PHOTOS

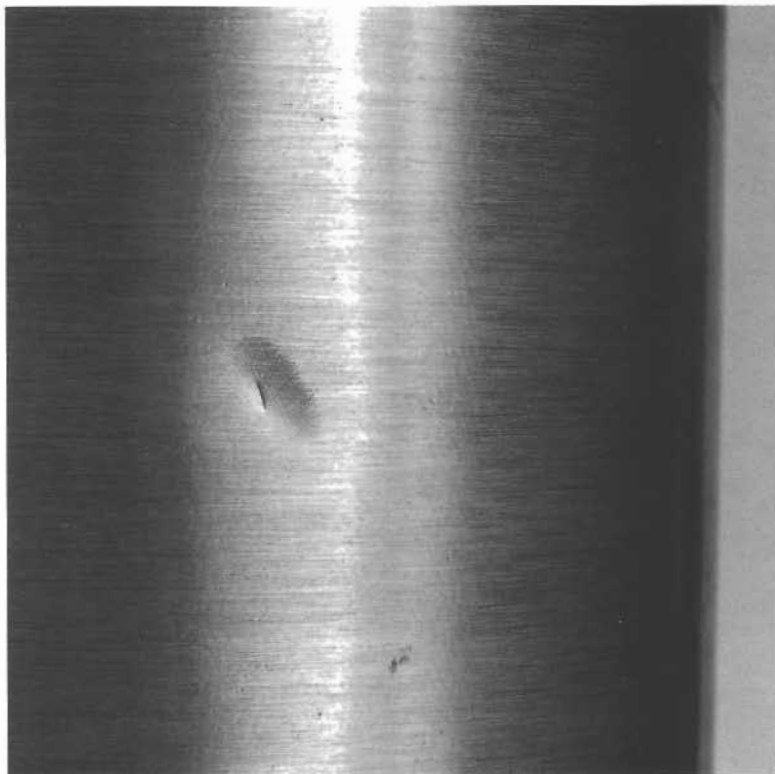
**PHOTO 1.** Dented cylinder.  
This cylinder has a 'brushed finish' with a clear coating.

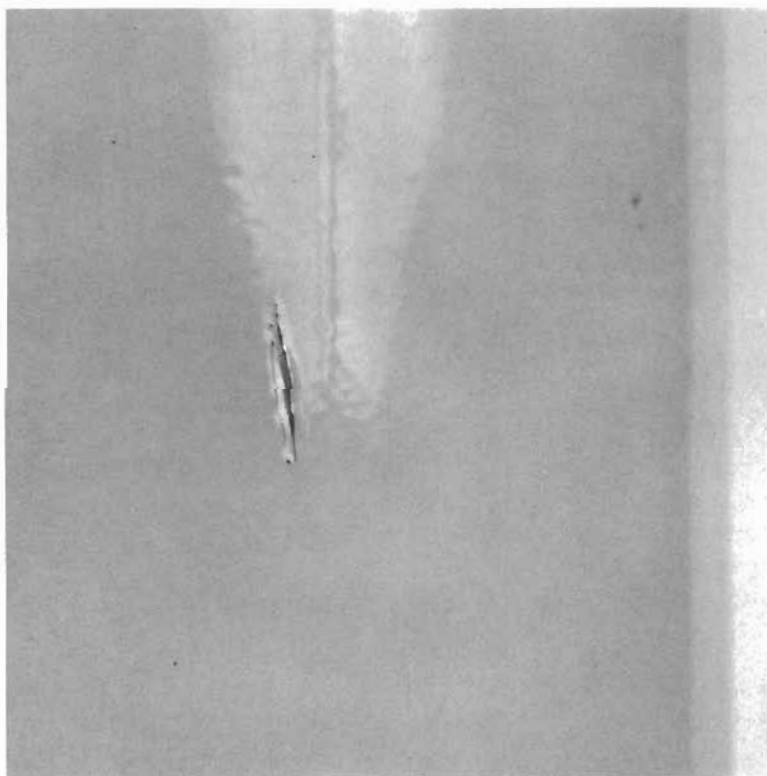
**PHOTO 2.** Gouged cylinder.

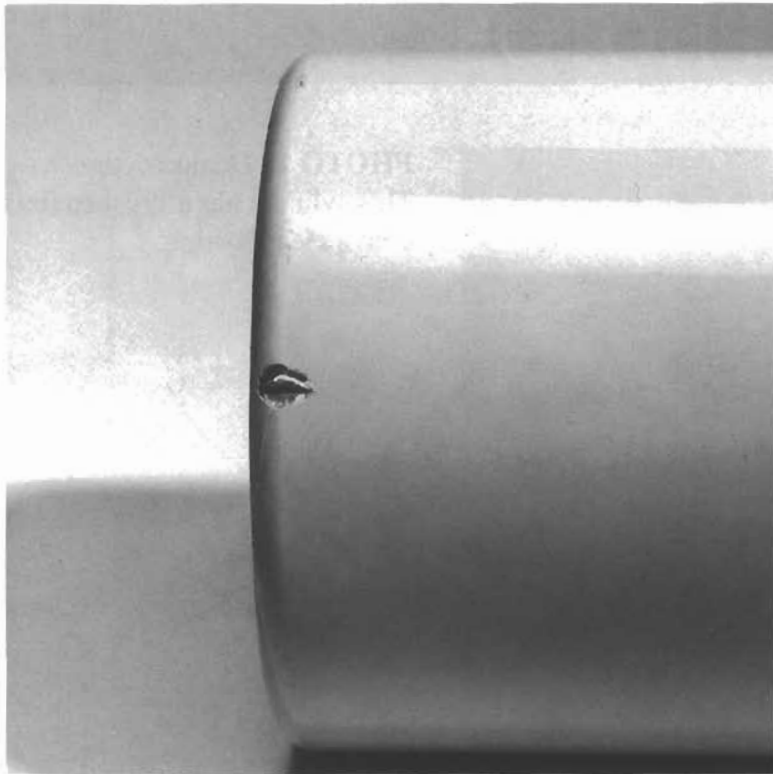
**PHOTO 3.** Cylinder shows signs of having been in an accident or dropped. May have been struck or fallen. The inspector, seeing an obvious deviation on an otherwise uniform cylinder should ask the owner if he/she is aware of any cause for such a mark.

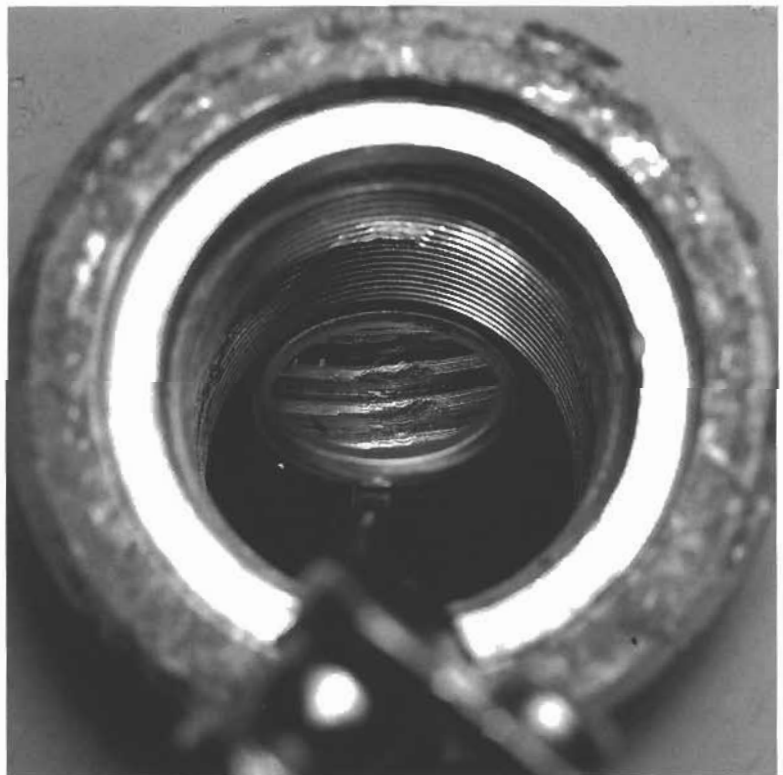
**PHOTO 4.** Damaged threads. Notice that, looking down on the threads, this damage is not readily apparent without the use of a dental mirror.

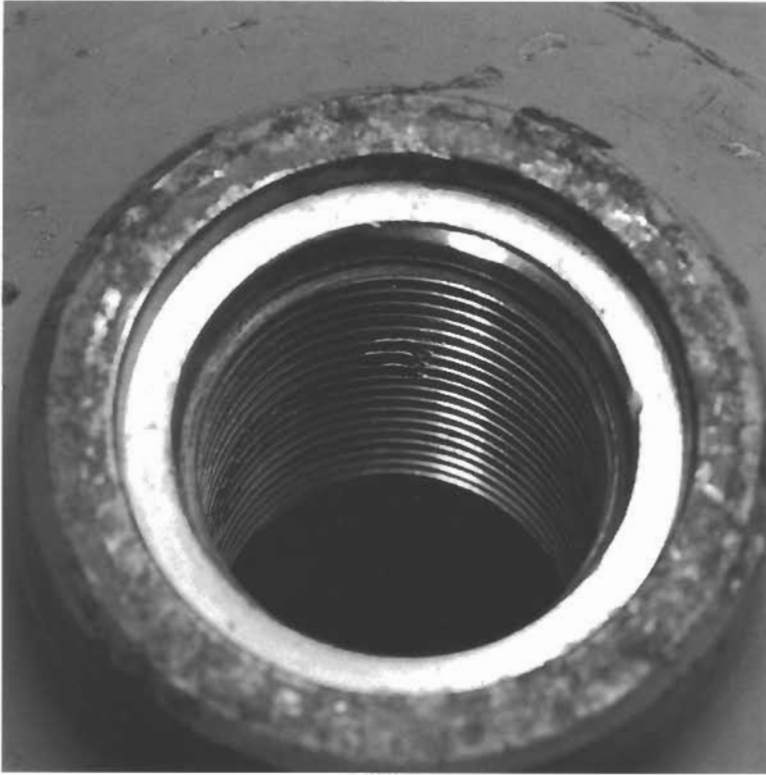
**PHOTO 5.** Damaged threads. This damage is easily seen with the naked eye, but the thread area is dirty and first needs cleaning (see NOTE 9), before proceeding with the visual inspection of the thread area.

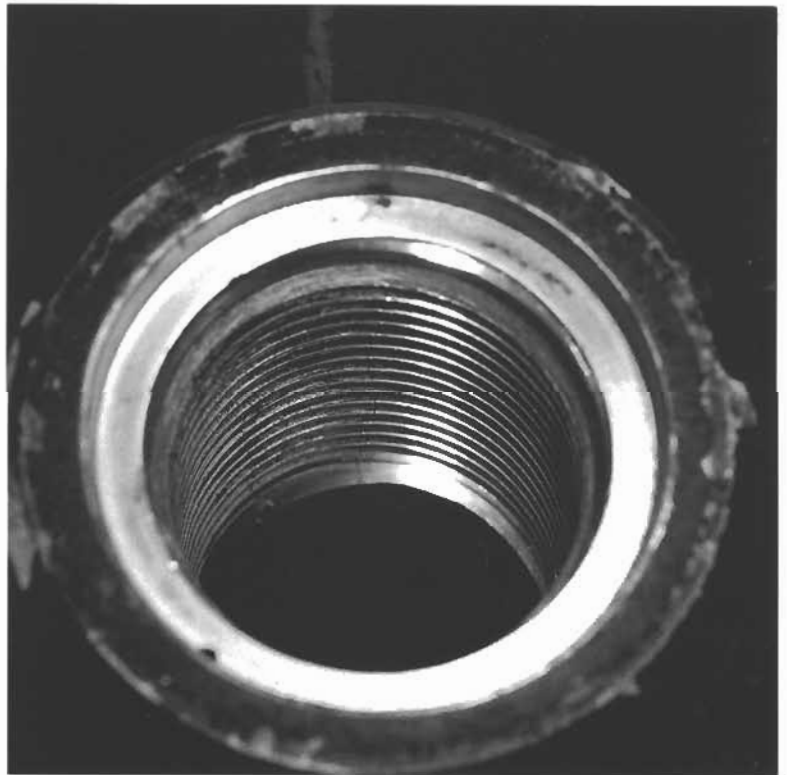
**PHOTO 6.** Cracked thread. This is a very subtle, hairline crack through most of the threads. Hard to see with the naked eye. It is usual for the crack to be jagged, rather than straight.

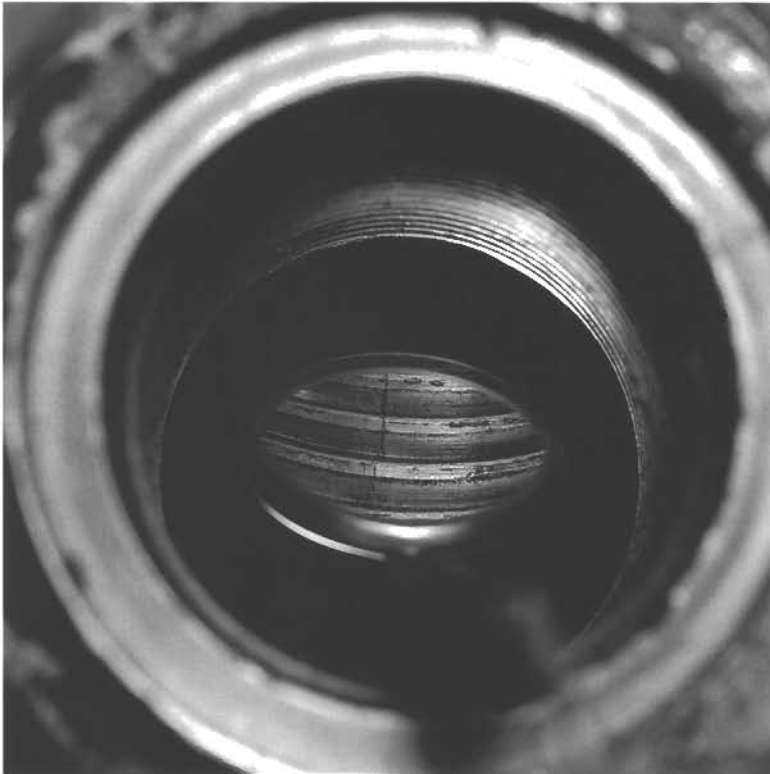
**PHOTO 7.** A crack in the threads found by the use of dental mirror.

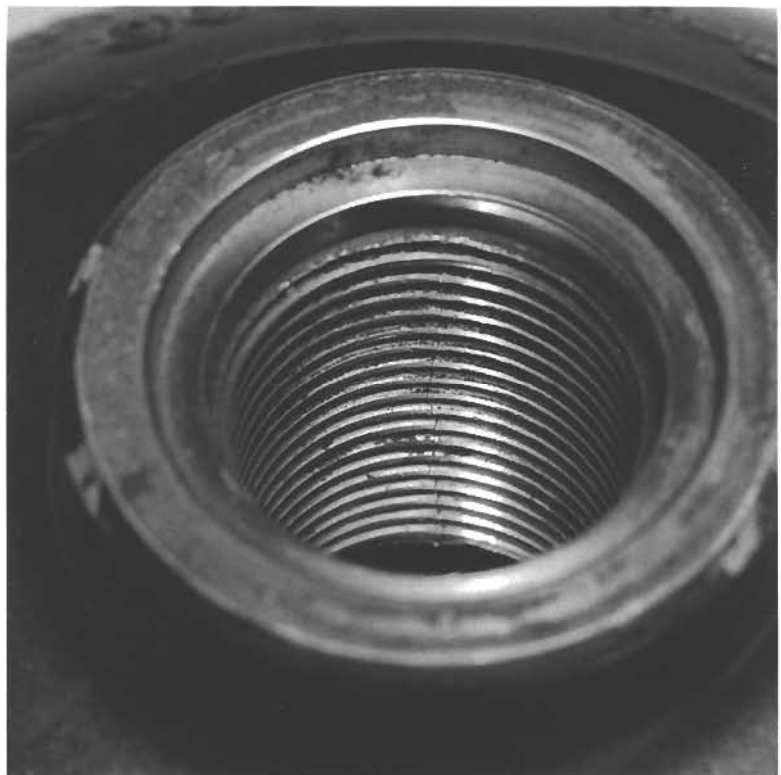
**PHOTO 8.** A crack in dirty threads. Threads need to be cleaned before the visual inspection begins. (See NOTE 9.)

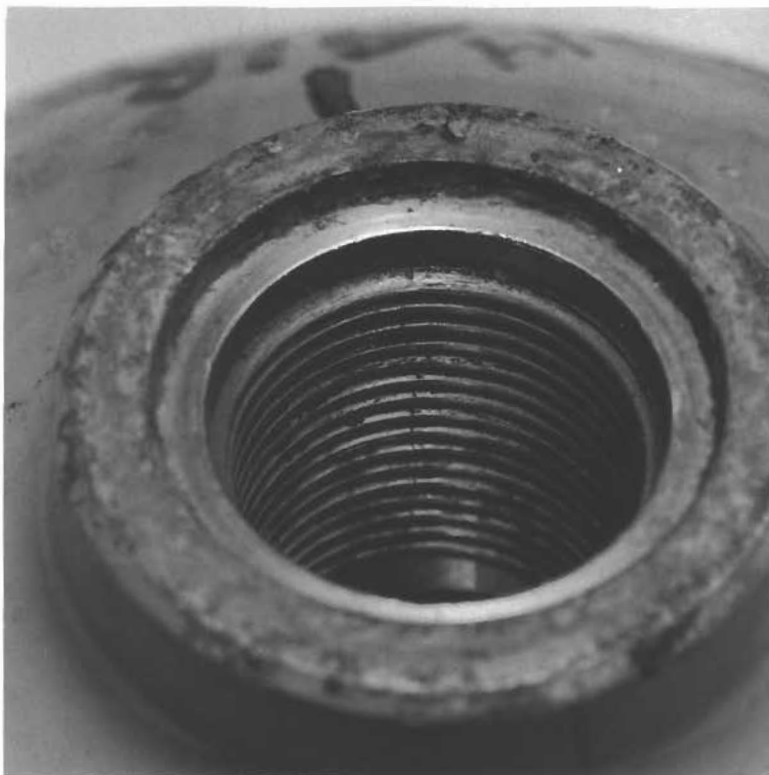
**PHOTO 9.** A crack easily seen with the naked eye, near the top or O-ring gland. A quick cleaning should be done, enough to verify that it is a crack.

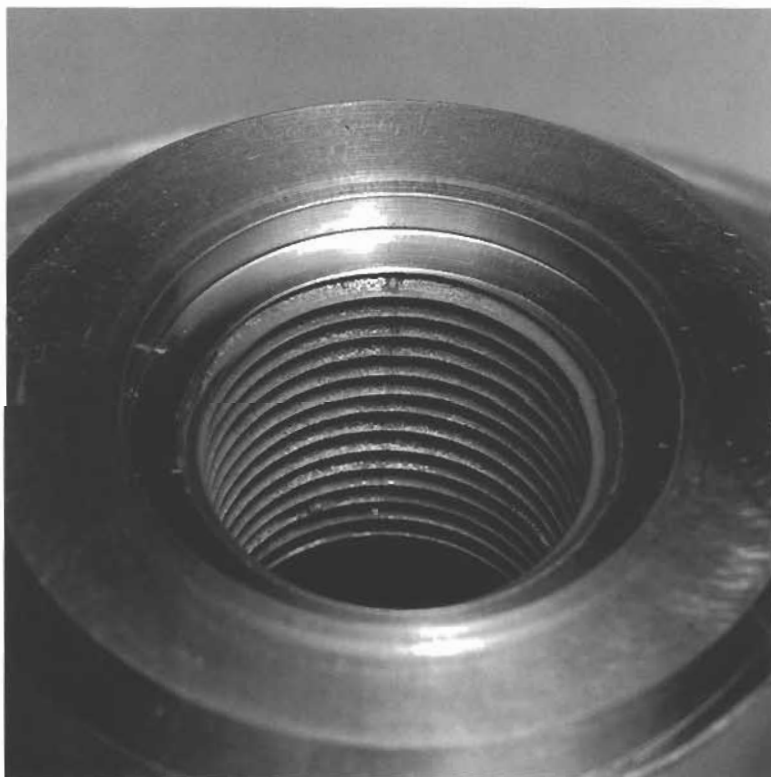
**PHOTO 10.** Example of a tool stop mark. Tool stop marks may appear to be like a crack, but the inspector will note that the tool stop is straight, through most of the threads, and is more like a wide smudge and contains no depth or opening. Careful inspection is important. Cracked cylinders are to be condemned; *cylinders with tool stop marks* that pass all other inspection criteria should be returned to service.

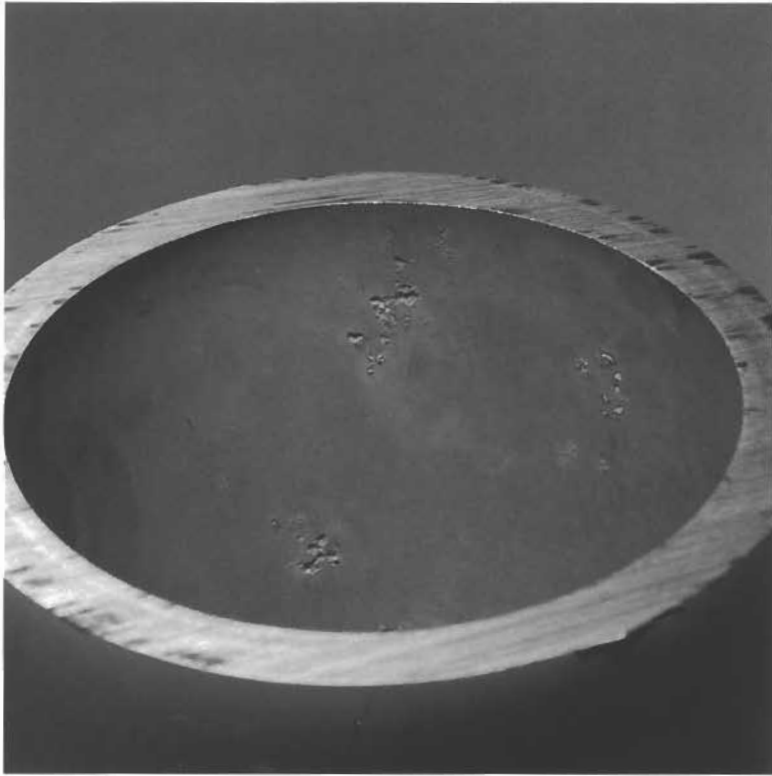
**PHOTO 11.** Pit corrosion in the cylinder sidewall, distant view.

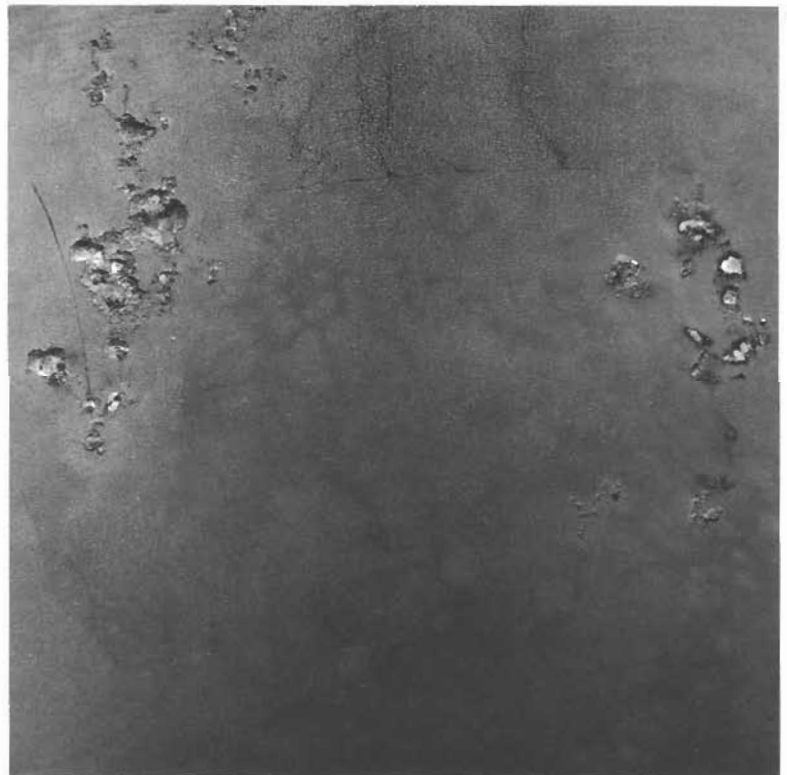
**PHOTO 12.** Close-up of pit corrosion from PHOTO 11.

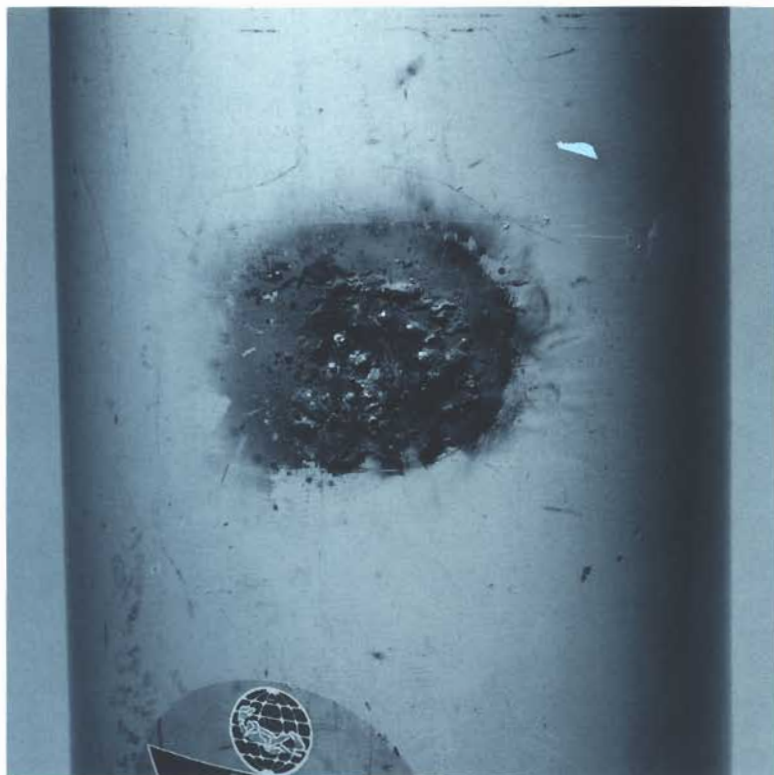
**PHOTO 13.** Appearance of fire or welding damage done to a scuba cylinder. Note the cylinder was approved on its last inspection (sticker) but since then, has been damaged by fire.

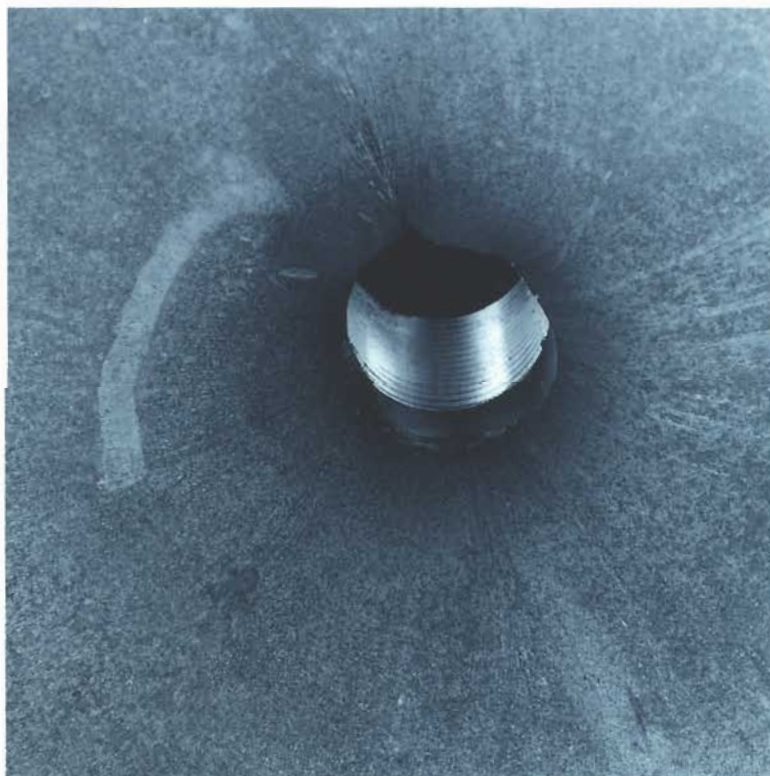
**PHOTO 14.** Inside view (looking from the inside towards the crown) of a fold near the threads.

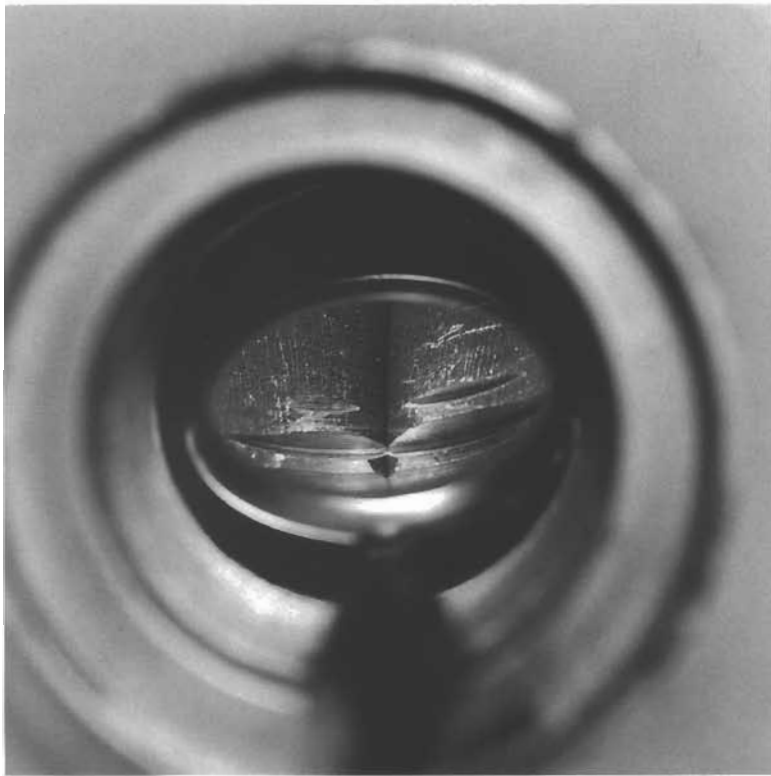
**PHOTO 15.** Fold near the thread region. Mirror view shows clearly that the fold does not enter into the full-thread area. This type of fold is acceptable if the depth of the fold is estimated to be less than 0.060 inch (1.53 mm).

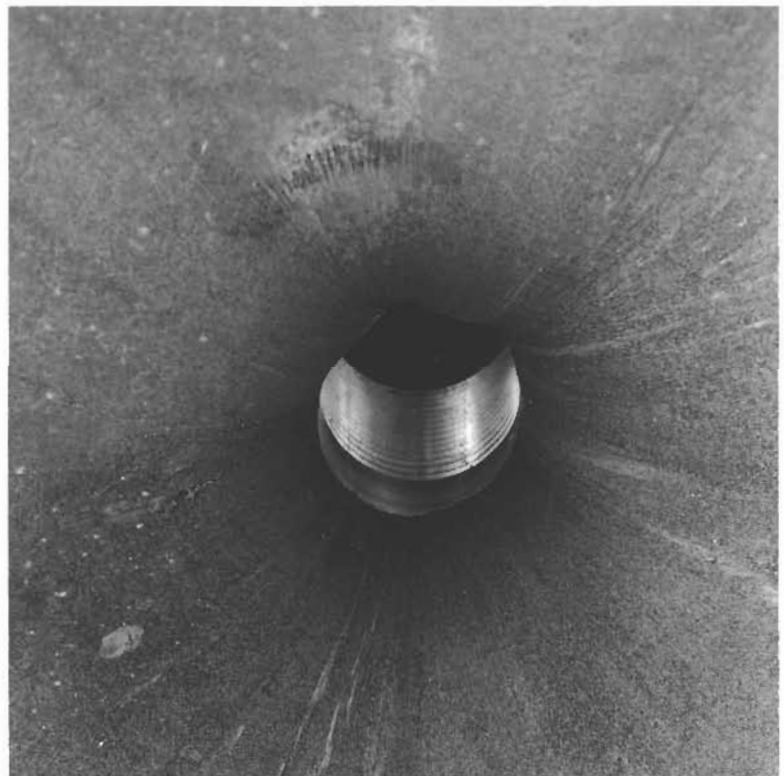
**PHOTO 16.** Inside view (looking from the inside towards the crown) of a valley.

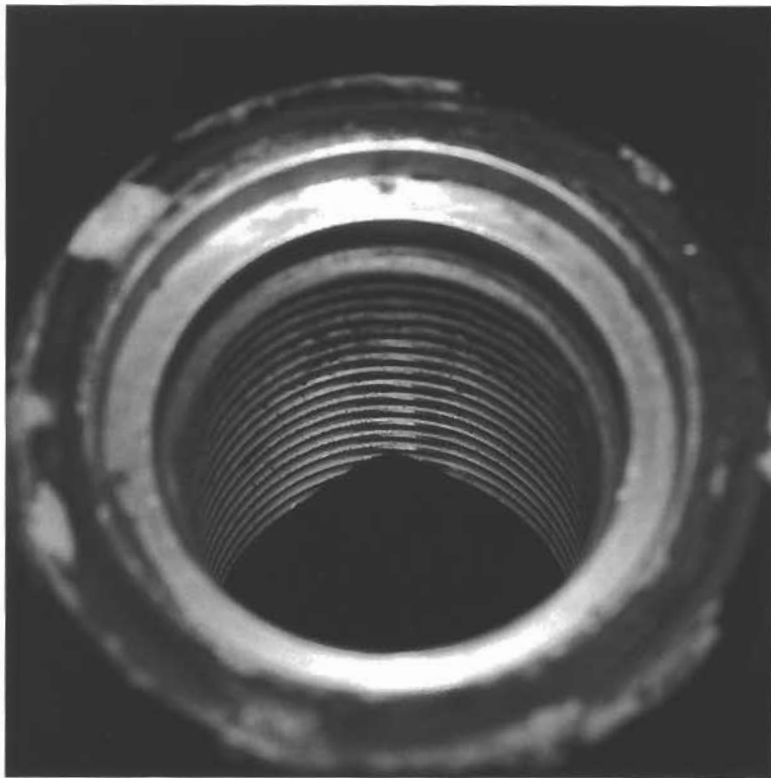
**PHOTO 17.** The appearance of a valley, looking into the cylinder at an angle.

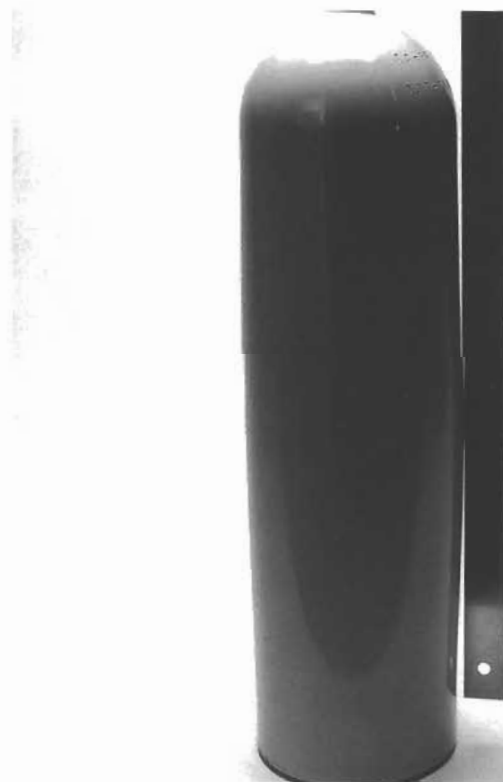
**PHOTO 18.** Cylinder with bow or "banana." The bow shows easily with a straight edge placed along the length of the cylinder (see FIGURE 11 of a bow 'from the other side').

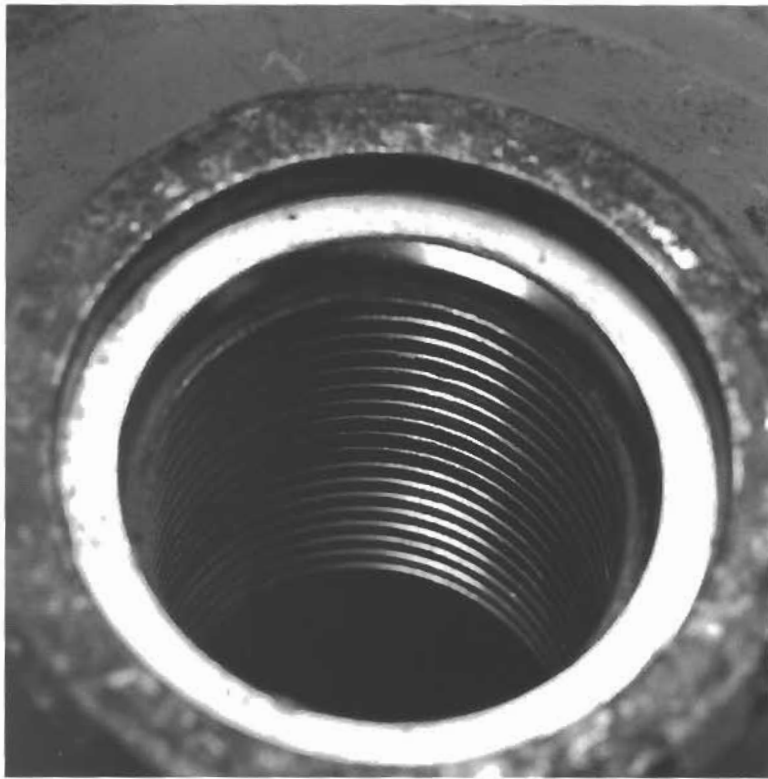
**PHOTO 19.** Dirty and worn threads. The threads at the bottom are worn and not as 'sharp' as the threads near the top. The threads need to be cleaned before counting the good threads (starting from the top).

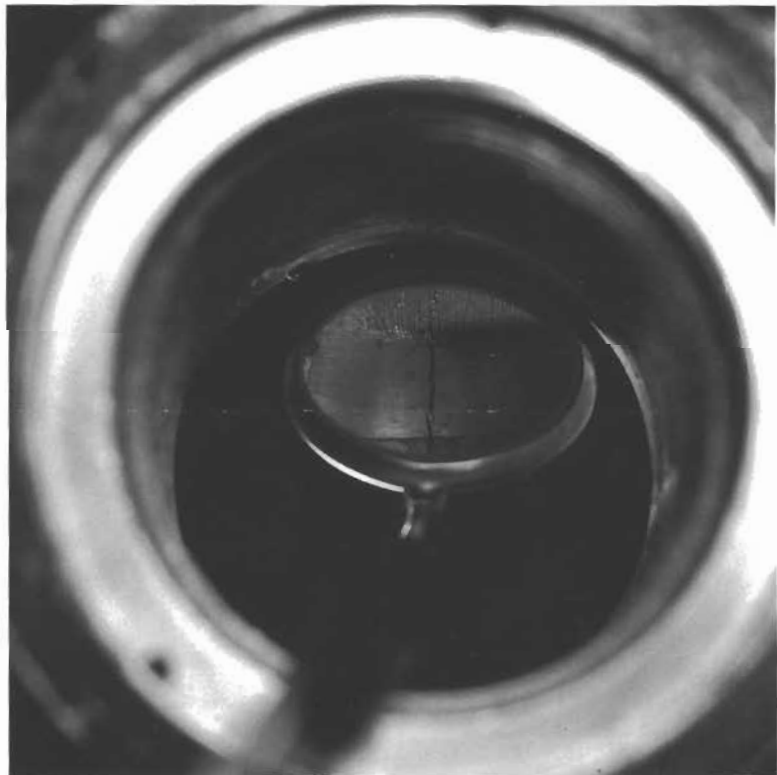
**PHOTO 20.** Crack in the crown, easily found with a dental mirror.
